Source: Linden's Handbook of Batteries, Fourth Edition, Fourth Edition

APPENDIX H: METHODOLOGIES FOR BATTERY FAILURE ANALYSIS

Quinn Horn, Troy Hayes, Daren Slee, Kevin White, John Harmon, Ramesh Godithi, Ming Wu, Marcus Megerle, Surendra Singh, and Celina Mikolajczak

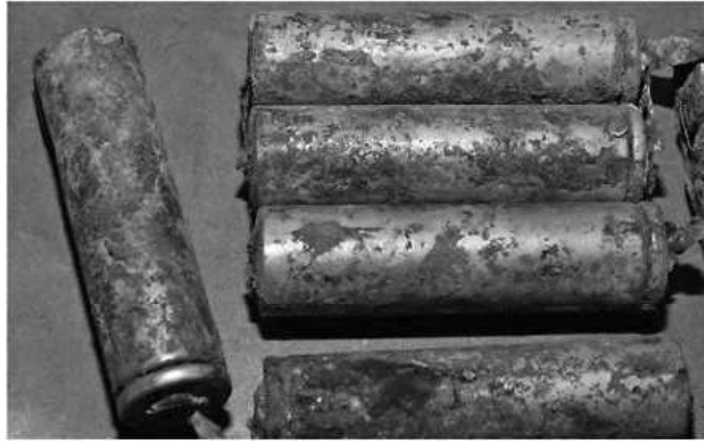
Figure H.1 Portion of a failed battery pack made up of 18650 lithium-ion cells. (Courtesy of Exponent, Inc.)

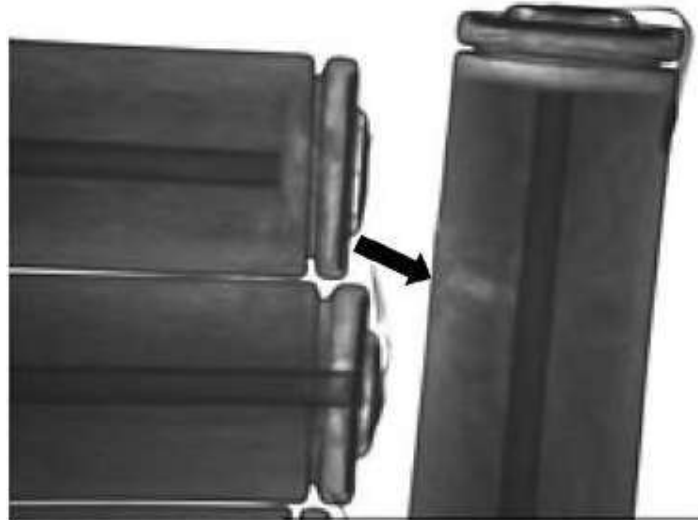
Figure H.2 X-ray image of part of a lithium-ion battery pack. The effect of cell venting from a cell cap on the windings of an adjacent cell can be observed, as indicated by the arrow. (Courtesy of Exponent, Inc.)

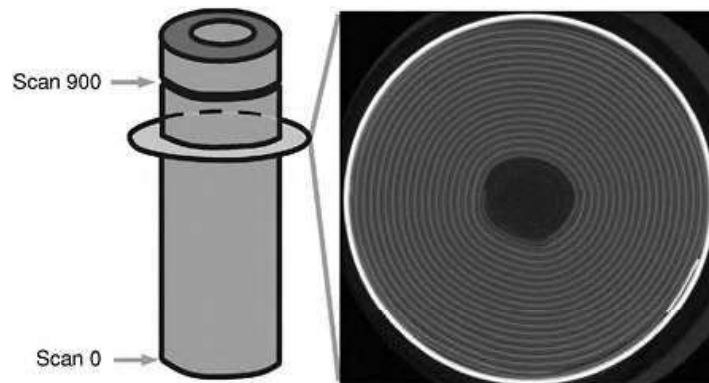
Figure H.3 A single CT scan cross-sectional image from a commercial 18650 cylindrical cell.
(Courtesy of Exponent, Inc.)

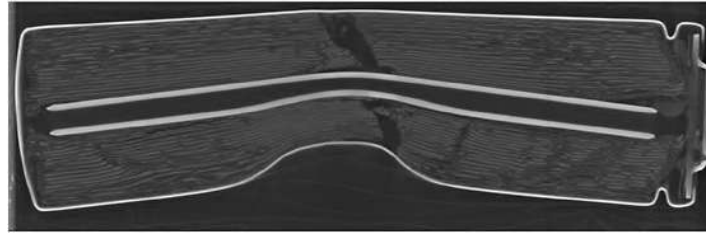
Figure H.4 CT scan cross-sectional image of a crushed cylindrical 18650 lithium-ion cell that subsequently underwent a thermal runaway reaction. (Courtesy of Exponent, Inc.)

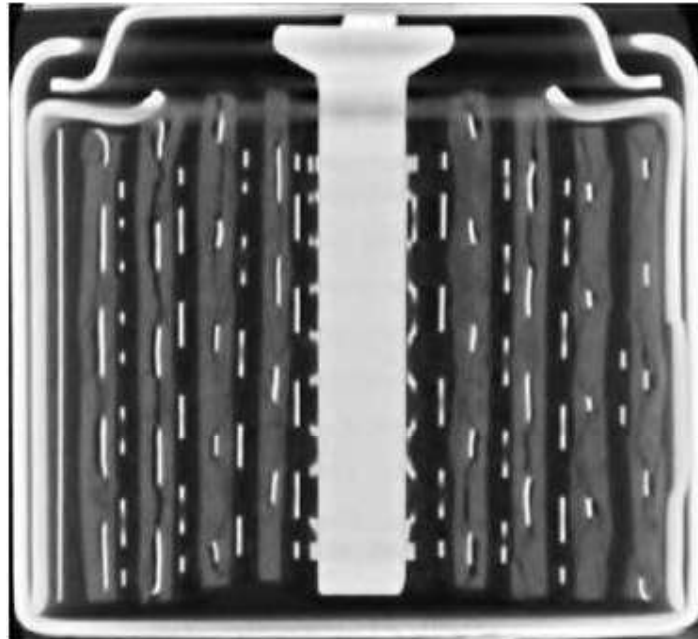
Figure H.7 CT scan cross-sectional image through the center of a CR1/3N lithium/manganese dioxide primary cell (50% SOC). (Courtesy of Exponent, Inc.)

[Figure H.7](#) is a CT image of the internal construction of a CR1/3N lithium/manganese dioxide primary cell at 50% state of charge (SOC). The cell has a spiral-wound construction utilizing wire mesh current collectors. The metallic parts, such as the steel can, metallic wire mesh electrodes, and center pin, appear as bright regions within the image. The cathode material corresponds to the gray regions within the image. The lithium metal corresponds to the black regions adjacent to the cathode material. The sealing surfaces are visible within the figure and appear to indicate a relatively uniform gasket compression with no signs of corrosion. The lithium metal has been consumed unevenly during discharge. This is clearly demonstrated in the image where the lithium metal has an uneven interface with the cathode active material. Additionally, voids and fractures are evident throughout the cell. The voids are coincident with the current collector mesh. Fractures of the cathode active material appear to propagate outward from those voids along the cathode active material current collector interface. This observation coupled with isolated voids adjacent to the current collector tends to indicate void formation occurs first, followed by fracturing of the cathode active material matrix as intercalation of the lithium into the manganese dioxide progresses during discharge.

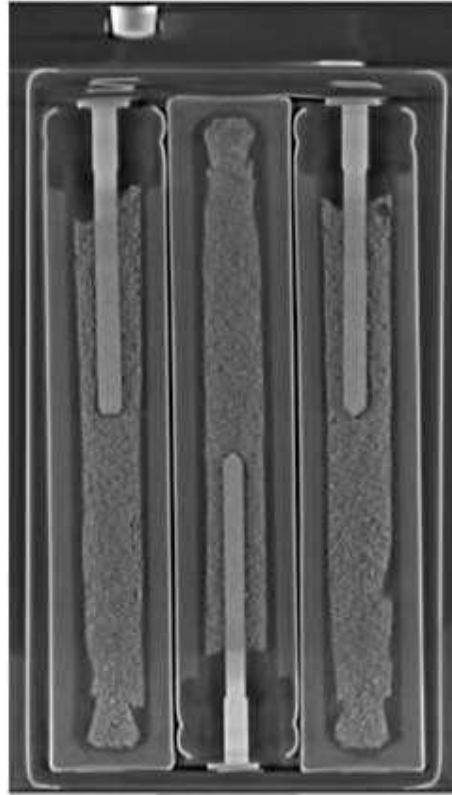
Figure H.8 CT scan cross-sectional image through three cells in a 9 V alkaline Zn/MnO₂ primary battery (100% SOC).

Figure H.8 shows a CT scan image of a 9 V alkaline zinc/manganese dioxide cell. There are six cells in series in alternating orientations within the battery (this cross section shows three of the cells). The zinc powder particles in the anode are clearly visible within the image. It is also apparent that the distribution of zinc is not uniform throughout the cells. There are irregularities along the anode/cathode interface as a result of folds and creases in the separator. Other features that are clearly illustrated include anode pin alignment, cell wall uniformity/integrity, and distribution of anode and cathode active materials.

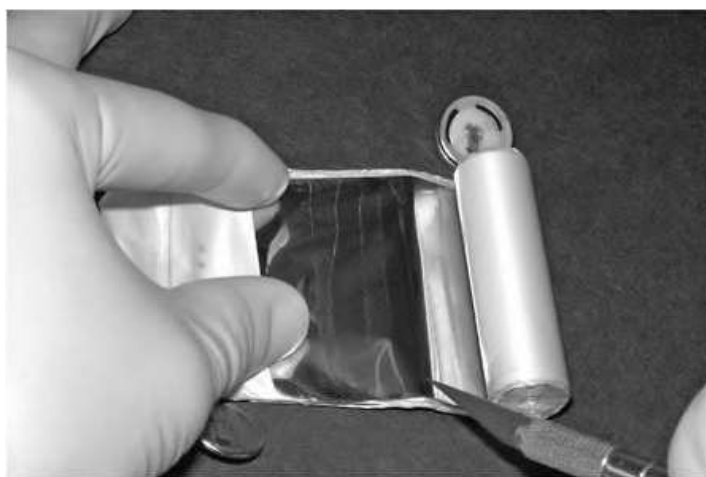
Figure H.9 Photograph showing the initial stages of the examination of electrode and separator surfaces of an 18650 lithium-ion cell. (Courtesy of Exponent, Inc.)

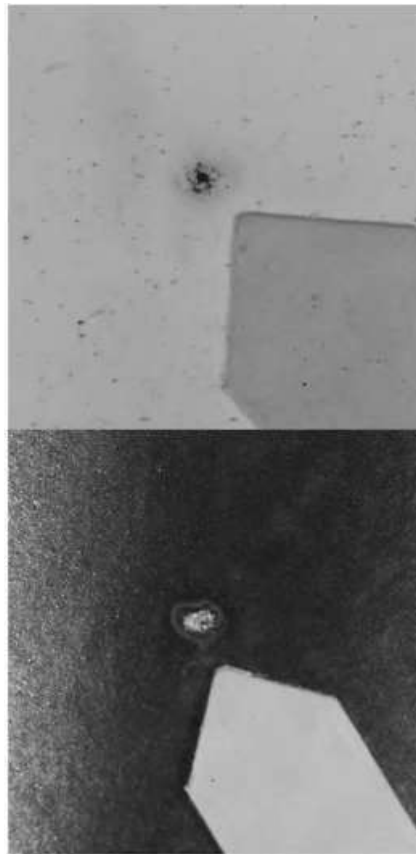
Figure H.10 Photographs showing evidence of a microshort on a separator (top) and associated anode material (bottom) observed during disassembly of a lithium-ion cell. (Courtesy of Exponent, Inc.)

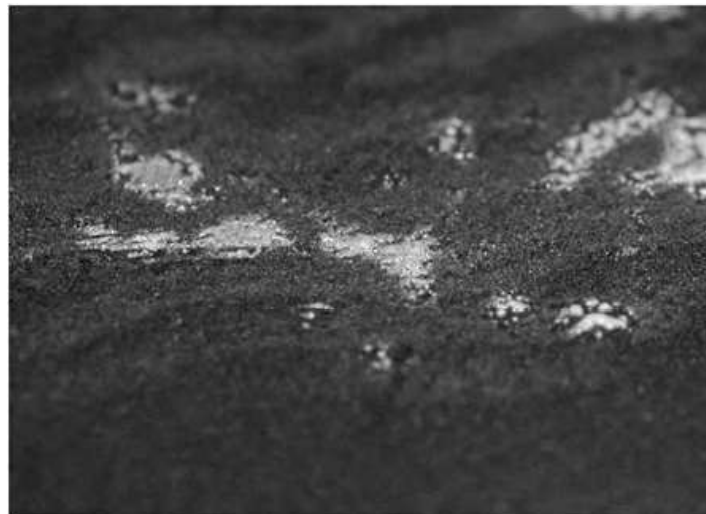
Figure H.11 Photograph showing evidence of lithium plating on the surface of the negative electrode removed from a discharged lithium-ion cell. In the presence of water vapor, white foam will form at locations of plated lithium due to the generation of lithium hydroxide and hydrogen gas. (Courtesy of Exponent, Inc.)

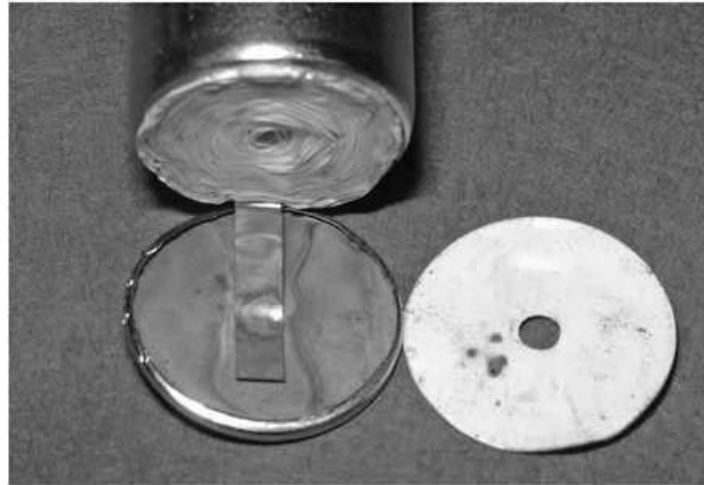
Figure H.12 Photograph showing indications of corrosion on the interior, bottom surface of the cell can from an 18650-size lithium-ion cell. (Courtesy of Exponent, Inc.)

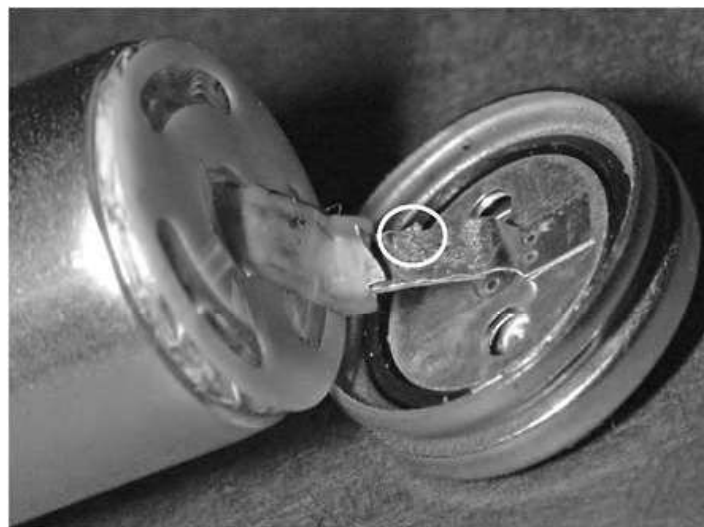
Figure H.13 Photograph of the cell cap assembly from an 18650-size lithium-ion cell showing evidence of a metal burr on the cathode lead edge (circled). (Courtesy of Exponent, Inc.)

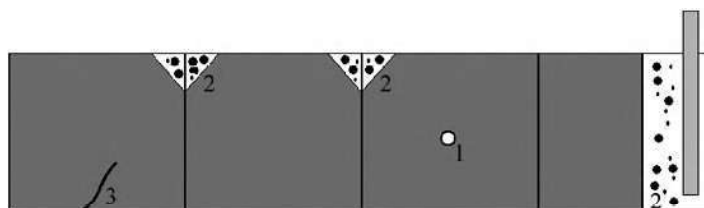
Figure H.14 Simplified schematic of a post-thermal runaway copper current collector from a wound prismatic cell depicting typical locations of damage: (1) hole surrounded by resolidified copper found in region of active material, (2) regions of copper aluminum alloying near anode lead tab and venting areas, (3) tear in current collector. (Courtesy of Exponent, Inc.)

For lithium-ion cells that have undergone thermal runaway, destruction of not just the cell separator, but melting of the aluminum current collector has likely occurred. In such cases, failure analysis proceeds with detailed examination of the remaining negative electrode (anode) material, particularly the copper current collector, which generally remains mechanically intact. Such examination often reveals the presence of holes in the copper current collector at a variety of different locations and with different character. Figure H.14 is a simplified schematic of a post-hermal runaway copper current collector, depicting representative locations of several types of holes observed.

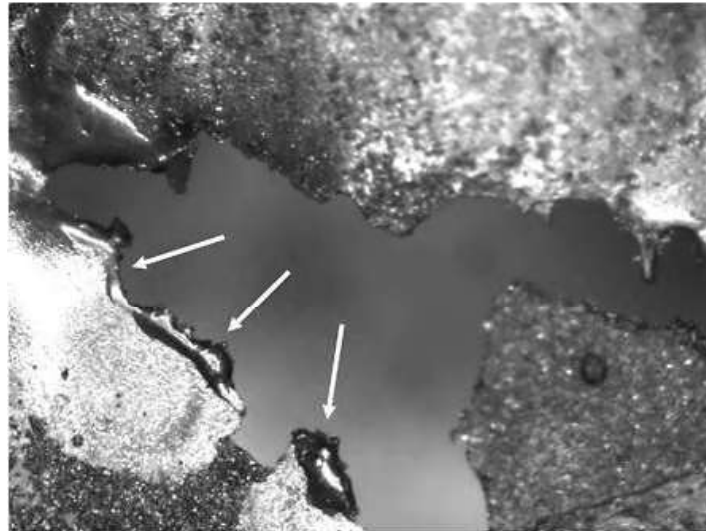
Figure H.15 Stereo-microscope image showing an example of a hole with a clearly defined melt front/ridge (arrows) from resolidified copper. (Courtesy of Exponent, Inc.)

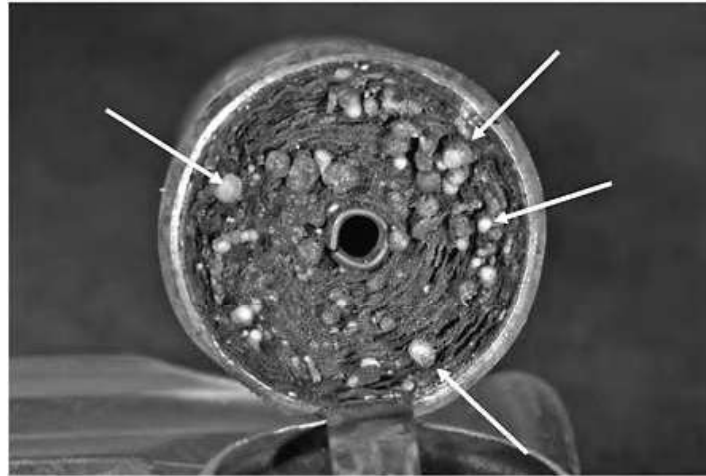
Figure H.16 Photograph of an 18650-size lithium-ion cell showing beads of resolidified aluminum visible at edge of cell winding after cell thermal runaway. (Courtesy of Exponent, Inc.)

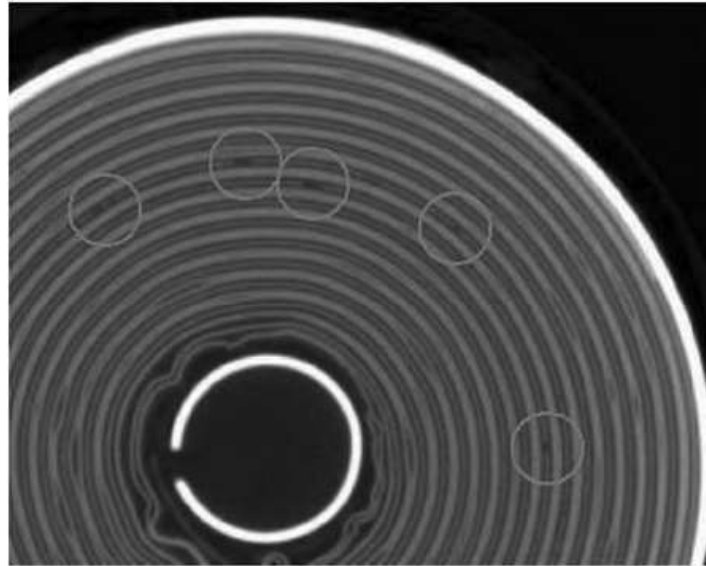
Figure H.17 CT scan of an 18650 lithium-ion cell subjected to severe overdischarge resulting in copper dissolution and the formation of fine holes in the copper current collector, particularly in the circled regions (thermal runaway did not occur). (Courtesy of Exponent, Inc.)

Cell overdischarge may cause copper dissolution to the point where numerous small holes form in the copper current collector. **Figure H.17** is a CT scan cross section of an 18650-type cell that was subjected to severe overdischarge (but has not undergone thermal runaway). In this image, the copper current collector appears as a thin bright line and the aluminum coated with cobalt oxide appears as a thicker gray line. In places throughout the cell, the copper current collector appears discontinuous—broken by a series of small holes, with diameters in the plane of the cross section on the order of the current collector thickness. These types of holes have been found to be the result of copper dissolution. **Figure H.18** shows one of these types of holes upon unrolling of a cell that has not undergone thermal runaway. The hole diameter here is on the order of the thickness of the coated anode layer.

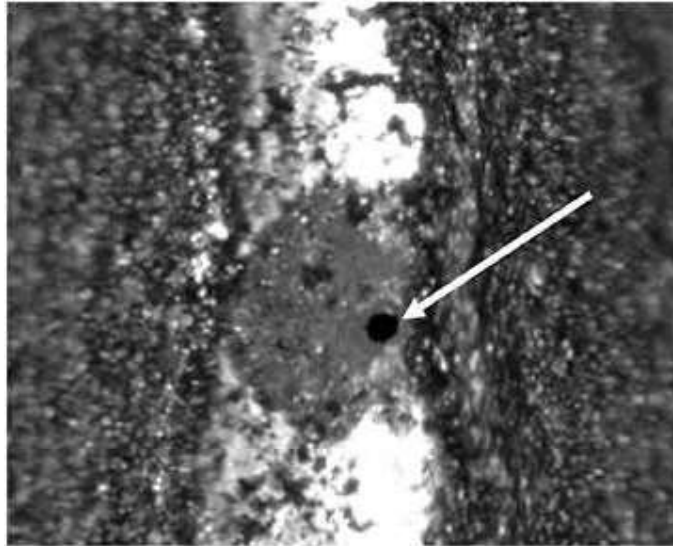
Figure H.18 Stereo-microscope image showing a hole in the copper current collector caused by overdischarge and copper dissolution. (Courtesy of Exponent, Inc.)

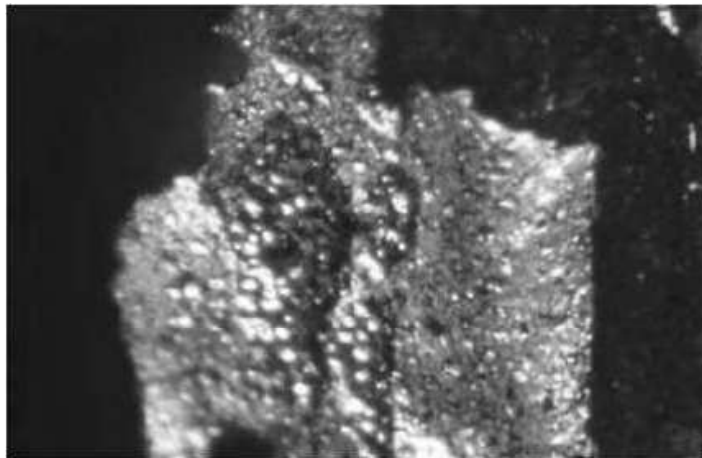
Figure H.19 Stereo-microscope image of pitting of the copper current collector surface associated with repeated severe over discharge. (Courtesy of Exponent, Inc.)

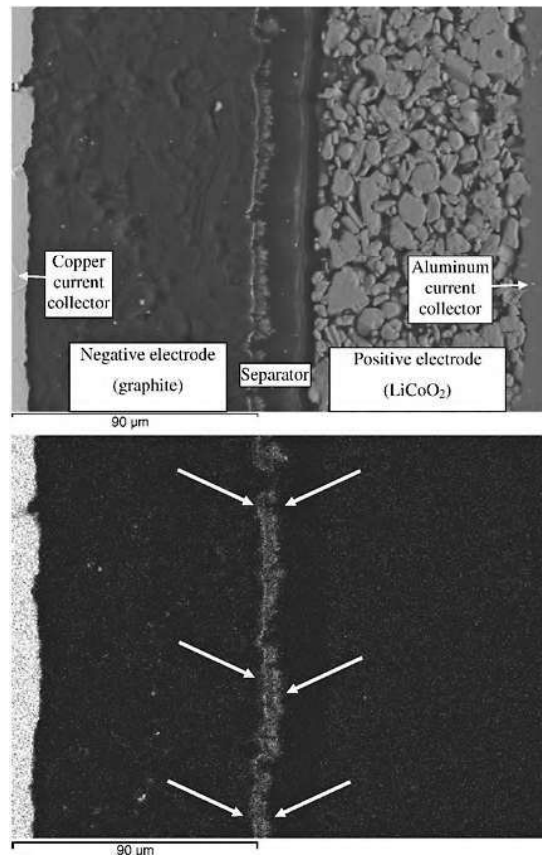
Figure H.20 SEM backscattered electron image of a D-size lithium-ion cell cross section (top) with a copper elemental map of the same region (bottom) showing copper dendrites growing through the separator from the negative to the positive electrode (between arrows). Cell cross-sectioning is discussed in the next section. (Courtesy of Exponent, Inc.)

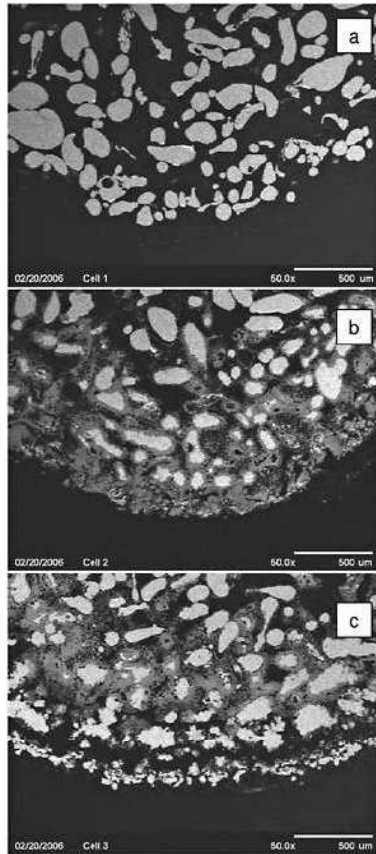
Figure H.21 SEM images (backscattered electron contrast) showing axial cross sections of AAA alkaline anodes. The bright regions are metallic zinc powder particles. The darker gray regions (images b and c only) are ZnO discharge product. (a) New, undischarged anode; (b) discharged at 300 mA to 0.8 V; (c) cycled three times at 300 mA from 1.65 to 0.8 V. The effect of cycling on metallic zinc segregation toward the separator is evident in (c). (Courtesy of Exponent, Inc.)

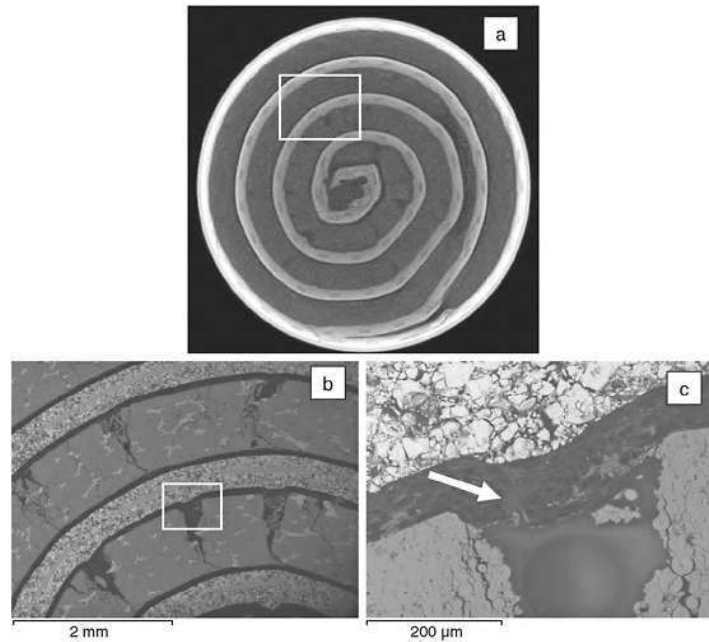
Figure H.22 Analysis of physical cross sections can complement nondestructive techniques such as CT scanning. An axial CT slice of a new AA NiMH cell is shown in (a), where cracking within the positive electrode is clearly evident. SEM (backscattered electron contrast) is shown in (b) and (c) for the same cell. From these images, tears in the separator can be found associated with the cracks in the positive electrode. These tears in the separator were found to be the root cause of rapid self-discharging and overheating of the cells in some devices. (Courtesy of Exponent, Inc.)

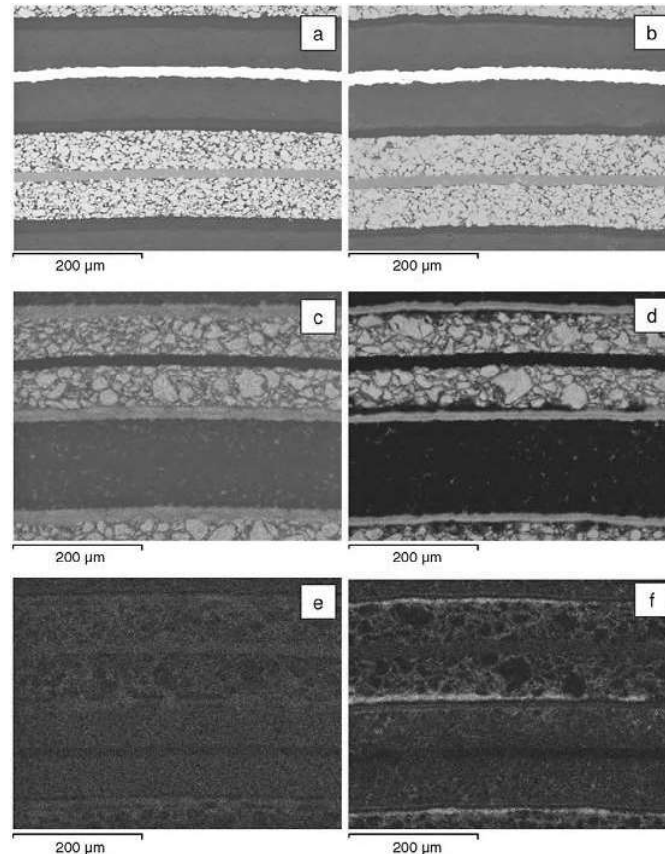
Figure H.23 SEM images (a and b) and associated carbon (c and d) and phosphorus (e and f) elemental maps. Images on the left were obtained from an axial cross section of an 18650-size lithium-ion cell, whereas the images on the right were obtained from a similar cell that was overcharged to 4.6 V. The effect of overcharging can be seen at the interface between the negative electrode and separator, where a thick phosphorus-rich layer is found. This phosphorus-rich layer is an electrolyte reduction product that forms from the reaction between metallic lithium and the electrolyte. (Courtesy of Exponent, Inc.)

An example showing the effect of overcharging on the microstructure of an 18650 lithium-ion cell is shown in Fig. H.23. In this figure, the top two SEM images (a and b) show the microstructure of identical cells. The cell in the left image (a) was cycled between 3.0 and 4.2 V, whereas the cell in the right image (b) was cycled between 3.0 and 4.6 V. It is apparent that the negative electrode in the cell that was overcharged to 4.6 V is significantly thicker than its 4.2 V counterpart. In the carbon elemental maps shown below the SEM images (c and d), the presence of a gap can be seen between the graphite particles and the separator in the cell that was over-charged. The phosphorus elemental maps shown at the bottom of the figure (e and f) indicate that a thick, phosphorus-rich film is present at the graphite/separator interface of the overcharged cell. This phosphorus-rich film is consistent with an electrolyte reduction product that forms when metallic lithium is plated on the surface of the graphite when the cell is overcharged.

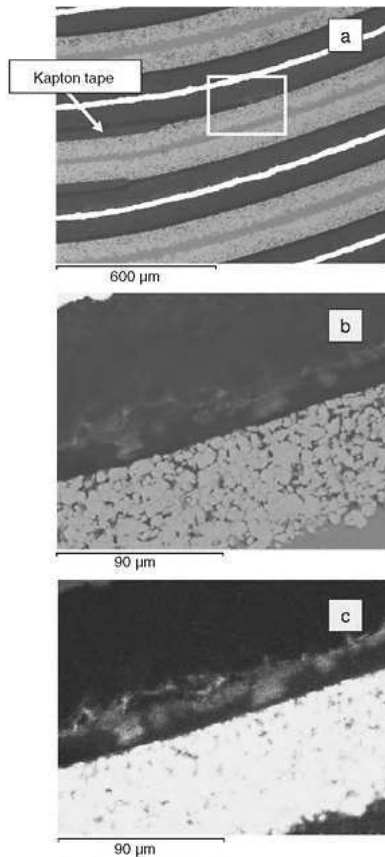
Figure H.24 (a and b) Scanning electron microscope images (backscattered electron contrast) showing intraseparator deposits growing from the negative to the positive electrodes in a high-power 18650 lithium-ion cell. The area within the white box in (a) is shown at a higher magnification in (b). The cobalt elemental map in (c) shows that these deposits are rich in cobalt. Dissolution of cobalt from Li_xCoO_2 resulted from the use of an incompatible adhesive on Kapton tape on the positive electrode leads. (Courtesy of Exponent, Inc.)

The cross-sectioning technique can also be useful for identifying internal microshorts in lithium-ion batteries. An example of this is shown in Fig. H.24 for high-power, 18650 lithium-ion cells that were prone to high self-discharge rates. In these cells, adhesive from Kapton tape on the positive electrode lead was in contact with delithiated Li_xCoO_2 . Incompatibility between the adhesive and the delithiated positive electrode material resulted in dissolution of cobalt and the deposition of a cobalt-rich compound on the negative electrode, which bridged the separator and resulted in a high resistance internal short-circuit path in these cells. In Fig. H.24b, the intraseparator deposition can be clearly seen, and the elemental map in Fig. H.24 shows that this deposit is rich in cobalt.
